OCTOBER 1963

# approach

THE NAVAL AVIATION SAFETY REVIEW

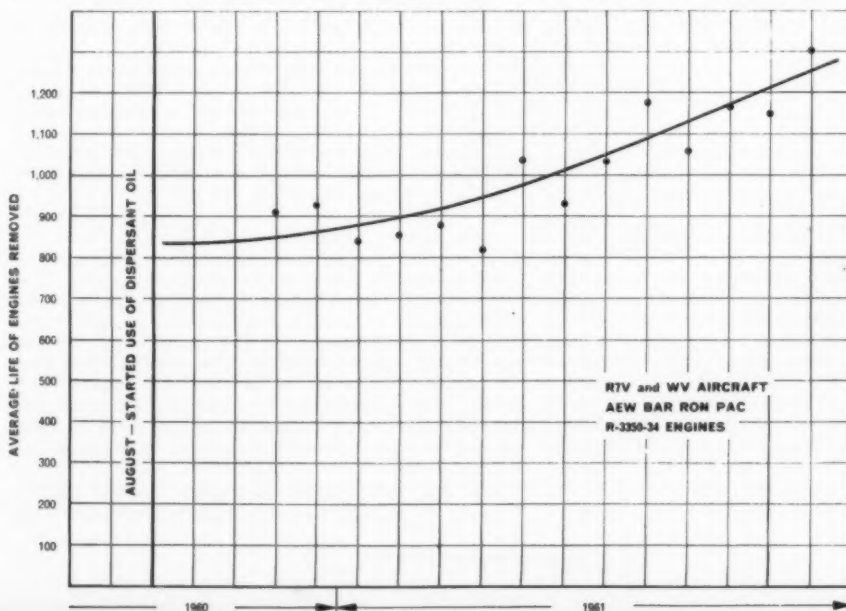
**FIGURE 5 (LEFT):** is based on statistical data submitted by Fleet Air Hawaii. Note the improved engine TBO.

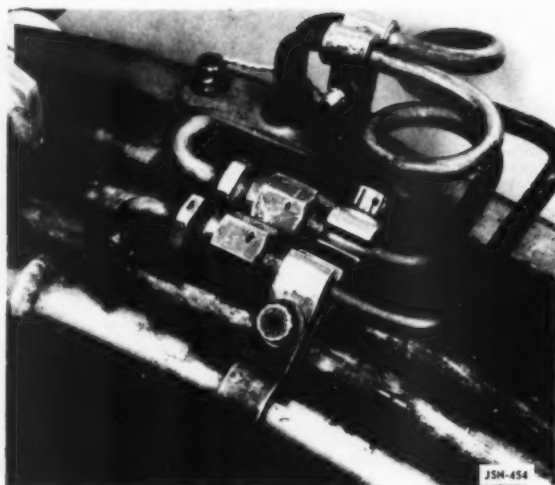
Figure 1 shows an example of improper clamping. The clamps have been placed between the spraybar tubes and the adjacent fuel manifolds.
